PROJECT : PDPU, GANDHINAGAR	DOC NO.: REPORT-01
DOCUMENT : ELECTRICAL ENERGY AND SAFETY AUDIT	REV NO: R1:25-06-19

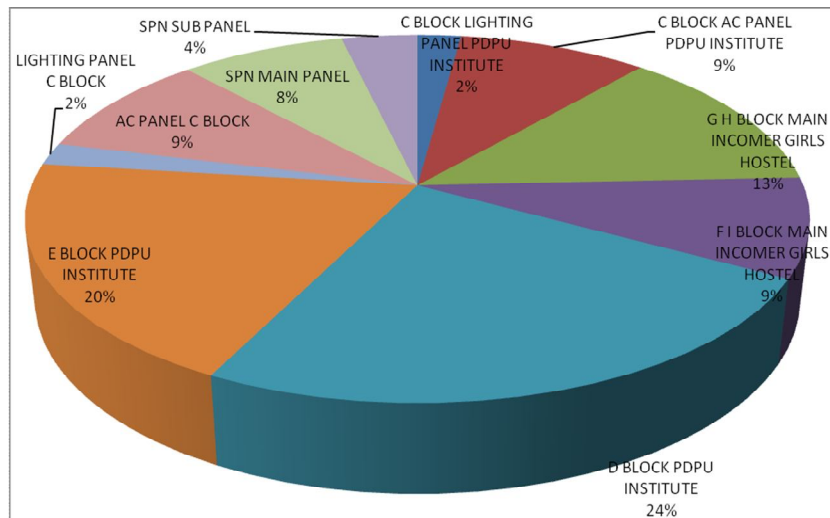
Above data is depicted in tabular form as below:

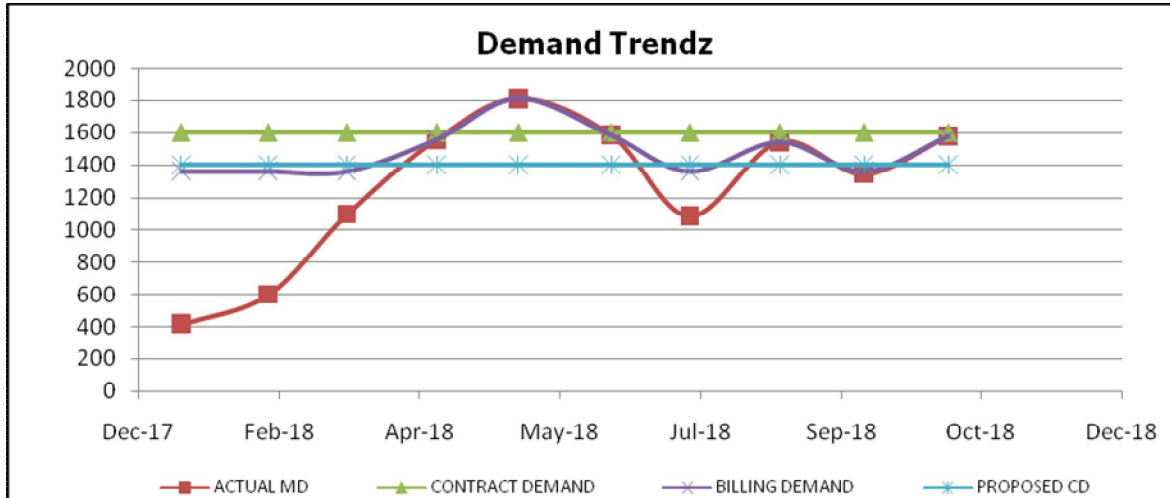
The month wise actual MD & Billing MD for past 12 months have seen shown in below:

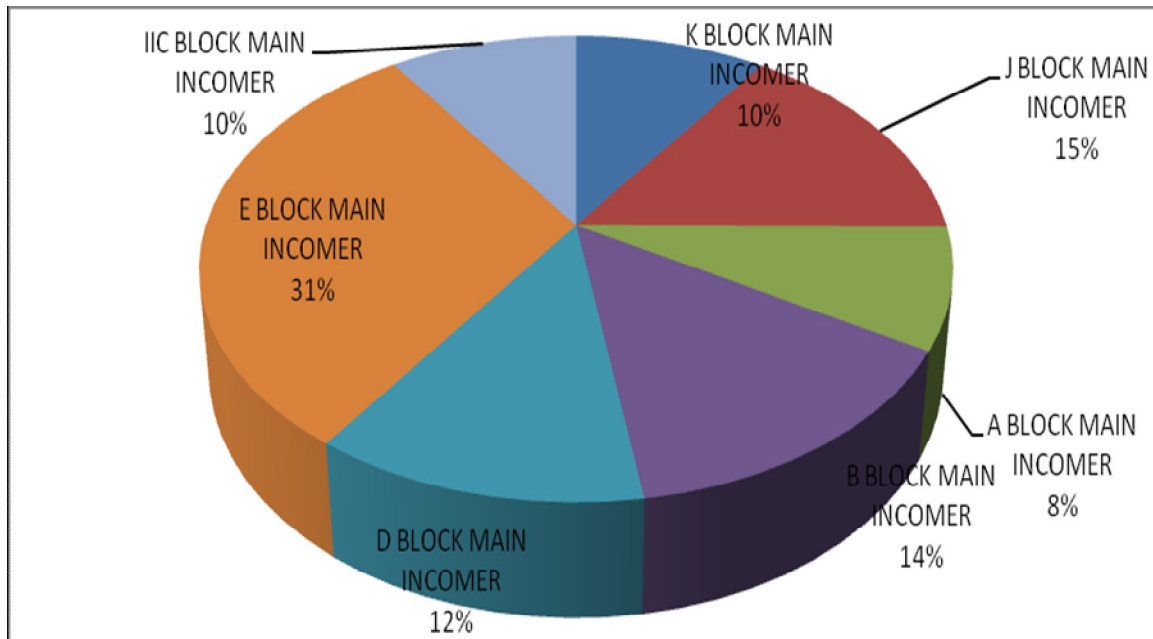
Above data is depicted in tabular form as below:

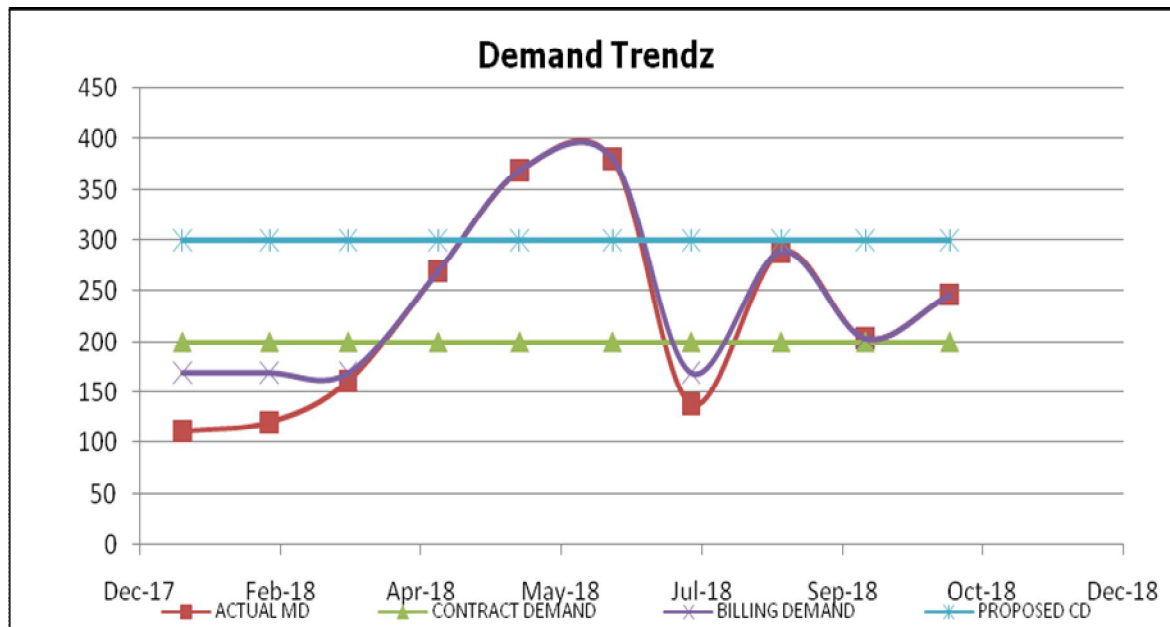
The month wise actual MD & Billing MD for past 10 months have seen shown in chart below

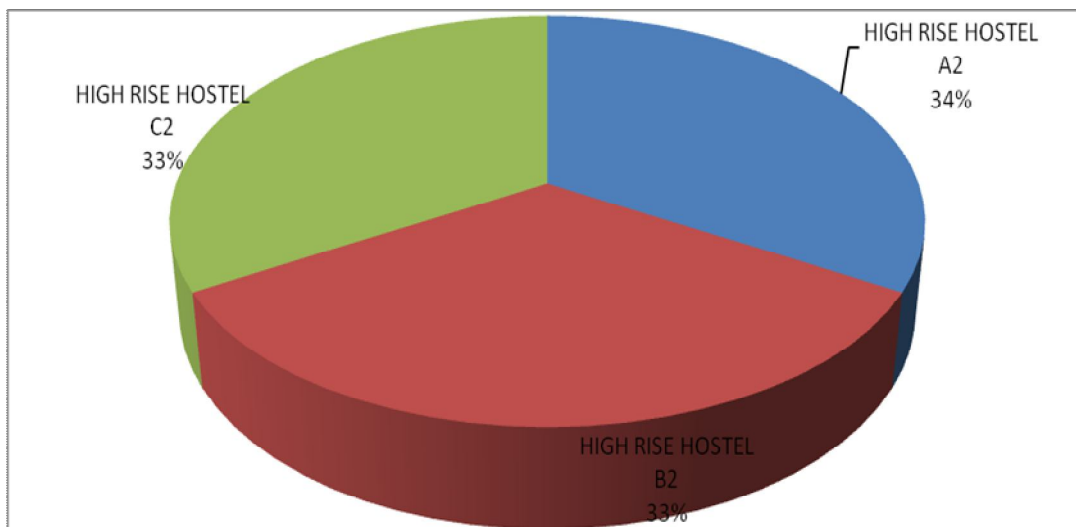
Above data is depicted in tabular form as below:

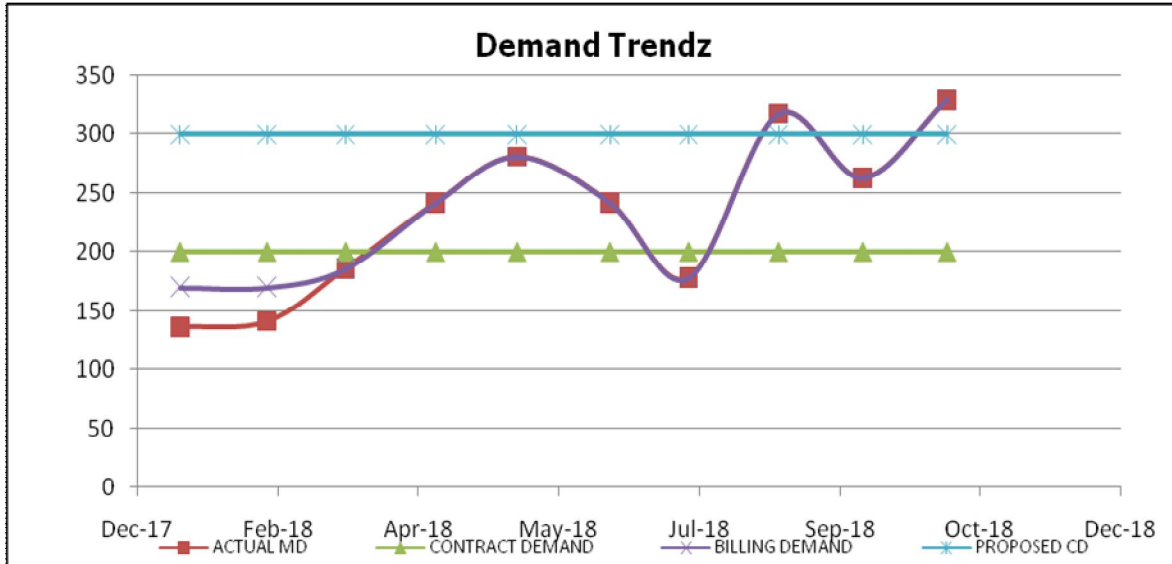
- The average billing demand was observed 238 KVA for last 10 months, which is Greater than 85% of contract demand of 170 kVA. There is drastic variation in demand (170 kVA in Jan '18 to 329 kVA in Oct'18). It is also observed that 06 times actual MD has crossed contract demand during last year, which has invited penalty rates of demand charges. So it is required to control the Contract Demand.
- The variation of consumption (total units) is shown as per chart below

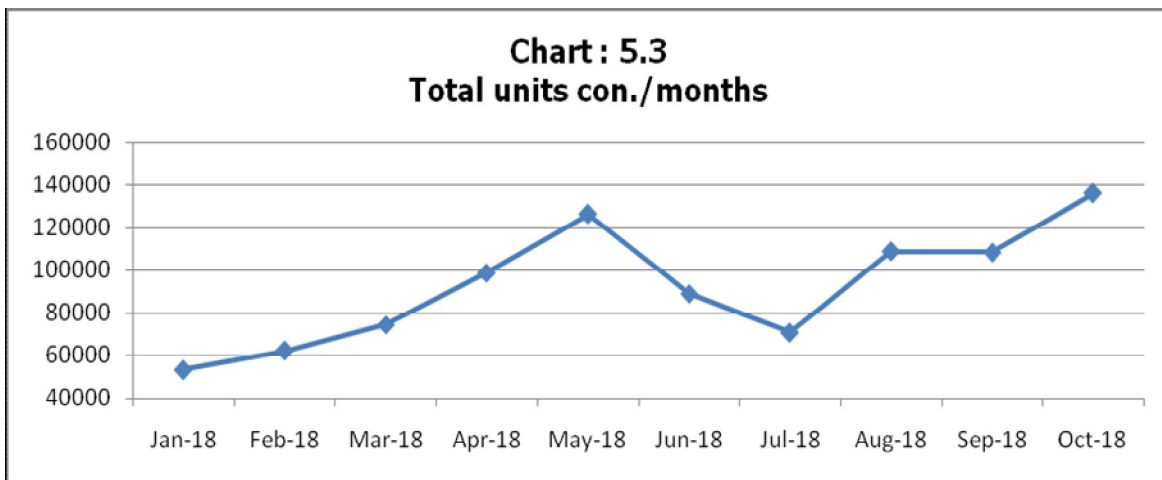
The power factor variation is as per the chart below:

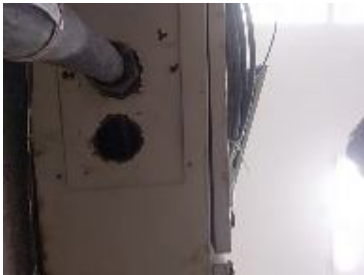
No
1.4.9	Statutory compliance certificate is obtained from authority	Yes but not updated
